**DOME**

**Damages on the dome arch beams and  
shutters**

**Code :** RPT/EDIF/0385-R  
**Issue :** 1.A  
**Date :** 05/03/13  
**No. of pages :** 23

Gran Telescopio de Canarias, S.A.

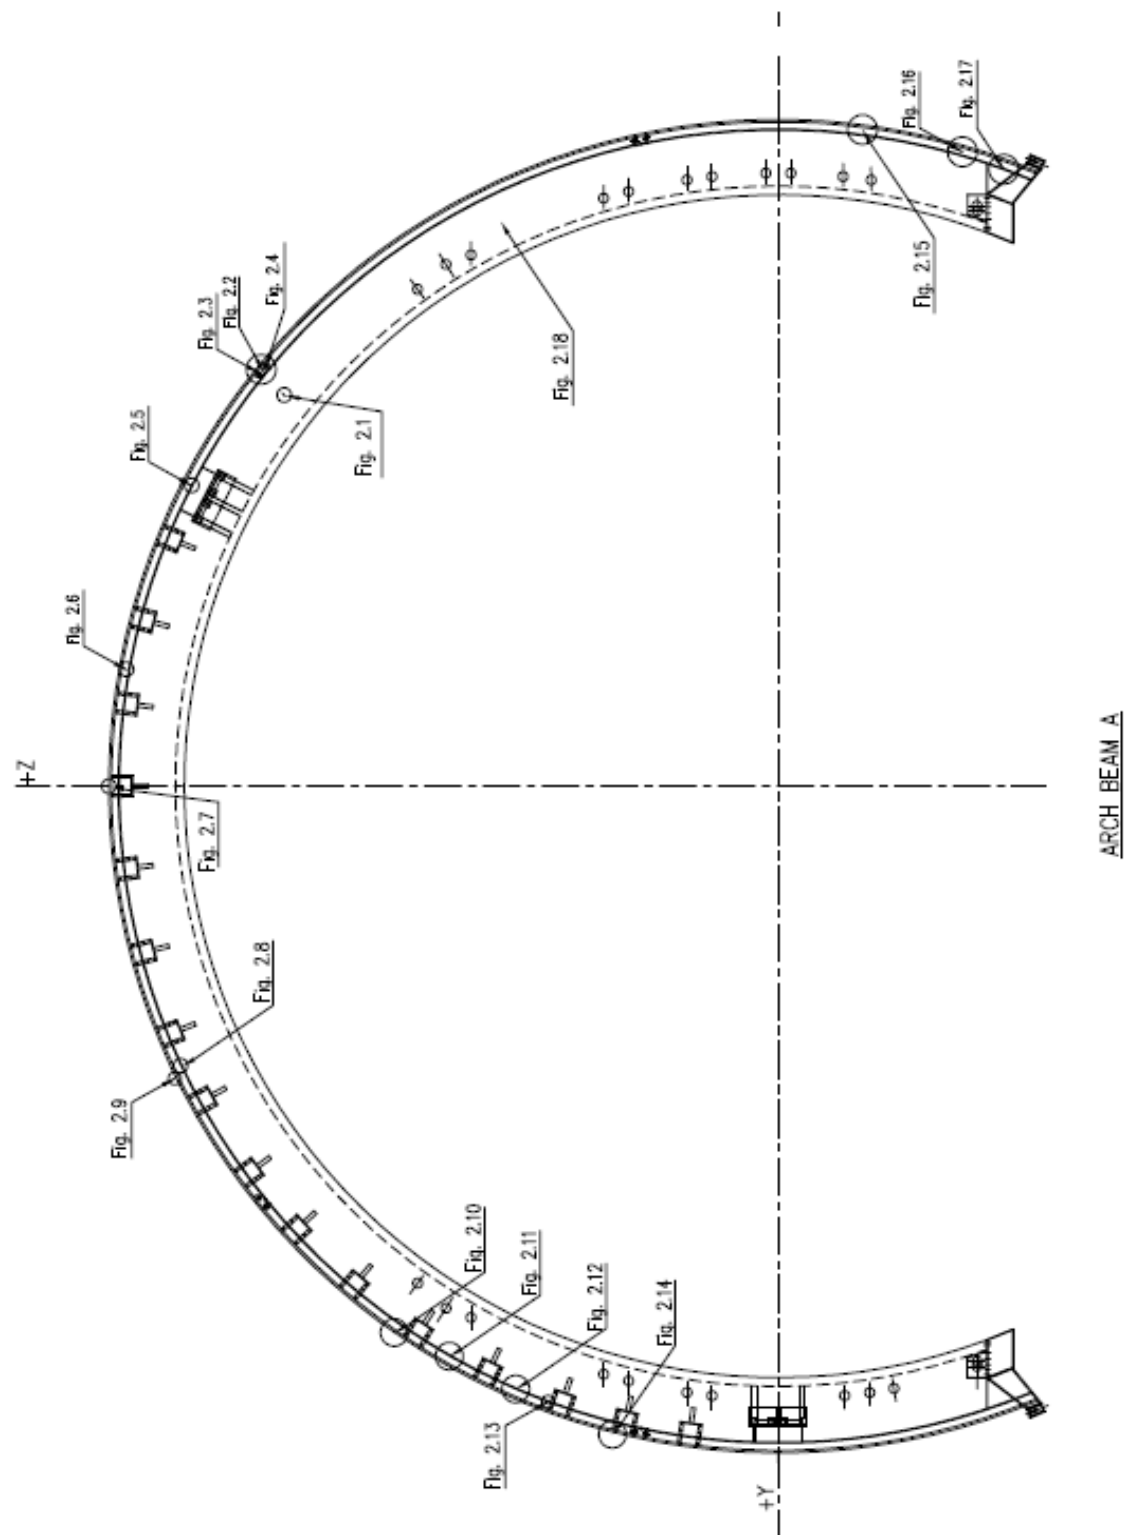
*Fig. 1.2 Schematic view of the defects on the arch beam "A"*

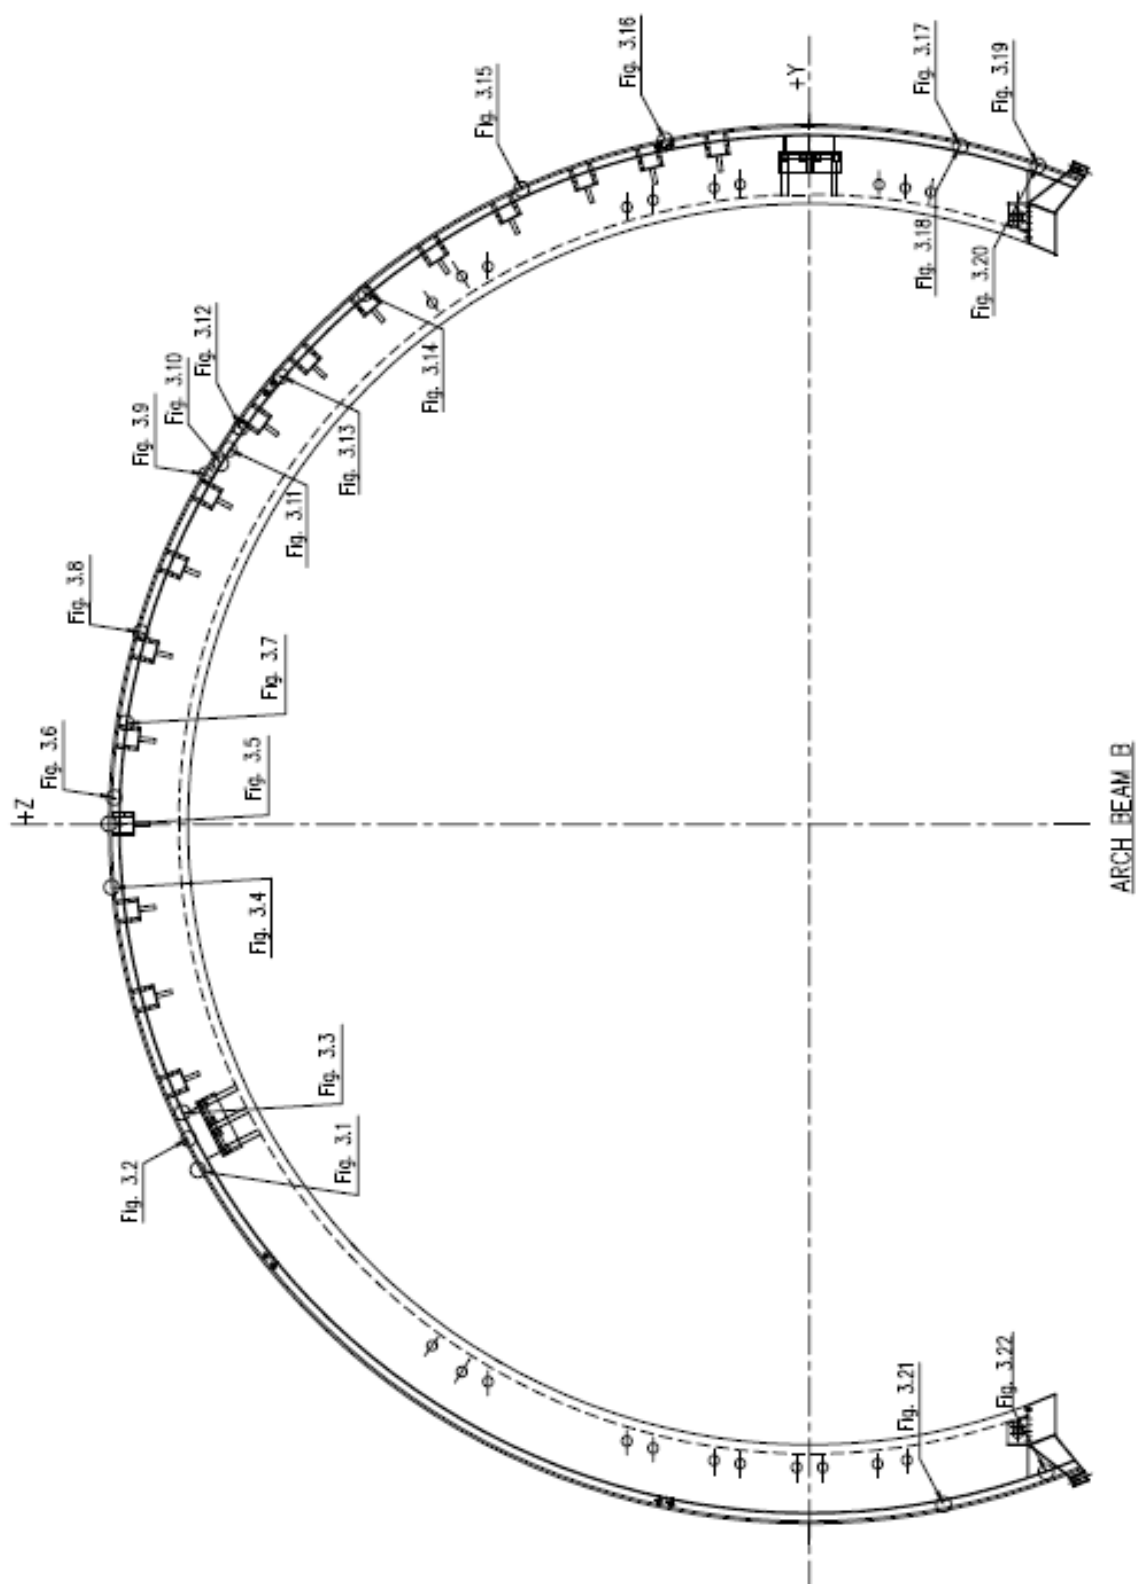
Fig. 1.3 Schematic view of the defects on the arch beam "B"

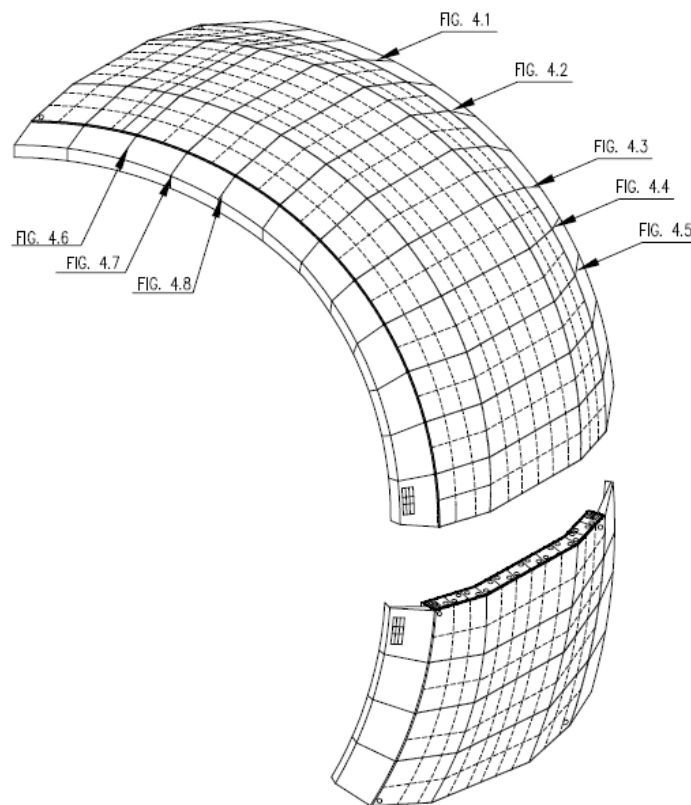
**Fig. 1.5** Location of the defects on the shutters.

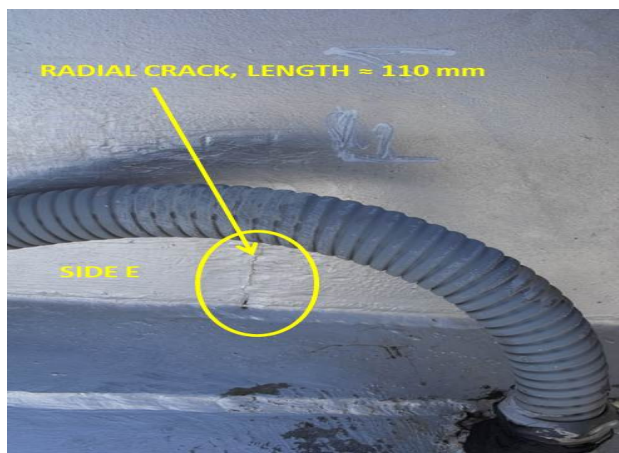
**Fig. 2.1** Radial crack. Side E.

| Identification | Pathology | Type | Approx. size | Location |
|---|---|---|---|---|
| Fig. 2.1 | Crack | Radial | 110 mm | Side E |

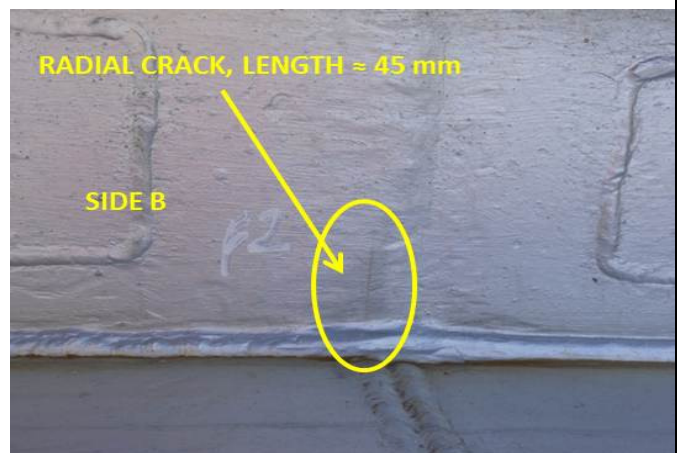
**Fig. 2.2** Radial crack. Side B.

| Identification | Pathology | Type | Approx. size | Location |
|---|---|---|---|---|
| Fig. 2.2 | Crack | Radial | 45 mm | Side B |

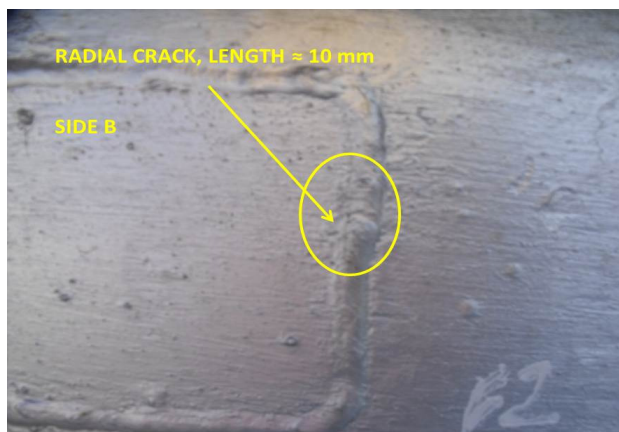
**Fig. 2.3** Radial crack. Side B.

| Identification | Pathology | Type | Approx. size | Location |
|---|---|---|---|---|
| Fig. 2.3 | Crack | Radial | 10 mm | Side B |

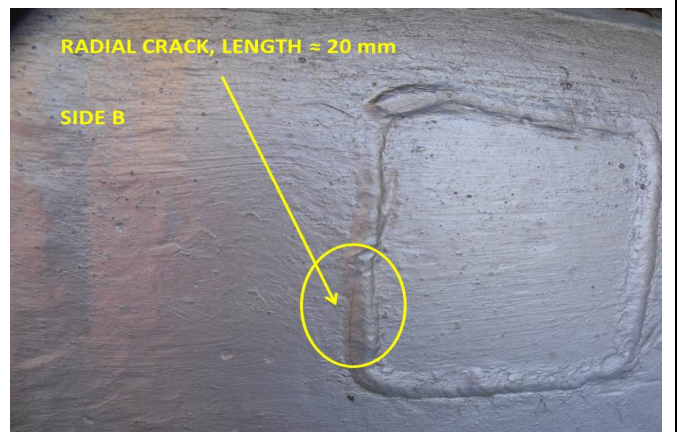
**Fig. 2.4** Radial crack. Side B.

| Identification | Pathology | Type | Approx. size | Location |
|---|---|---|---|---|
| Fig. 2.4 | Crack | Radial | 20 mm | Side B |

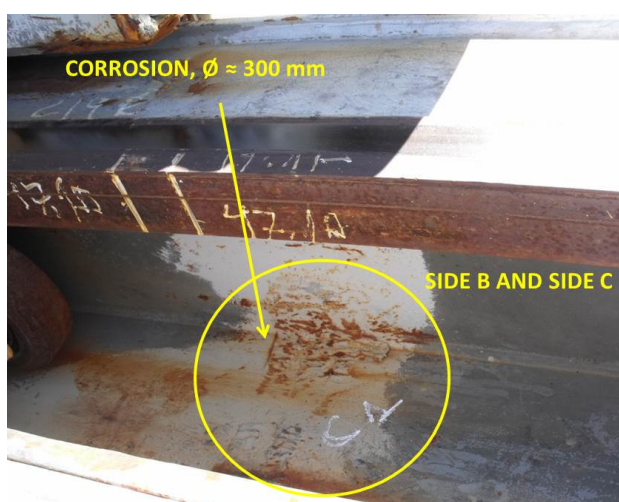
**Fig. 2.5** Corrosion. Side B and side C.

| Identification | Pathology | Type | Approx. size | Location |
|---|---|---|---|---|
| Fig. 2.5 | Corrosion | Rust | Ø300 mm | Side B and Side C |

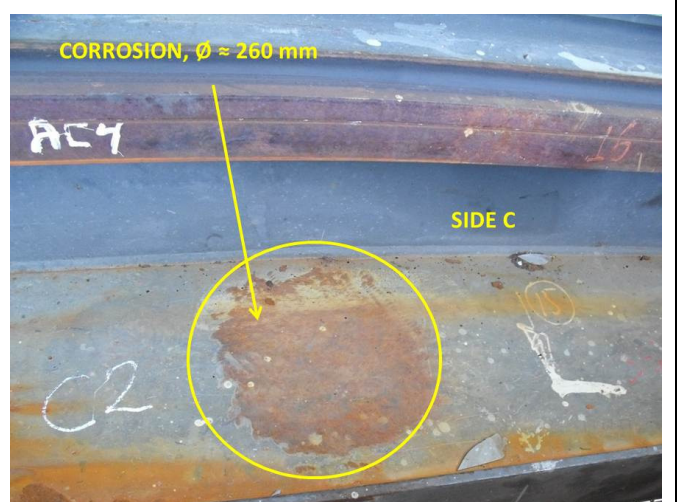
**Fig. 2.6** Corrosion. Side C.

| Identification | Pathology | Type | Approx. size | Location |
|---|---|---|---|---|
| Fig. 2.6 | Corrosion | Rust | Ø260 mm | Side B |

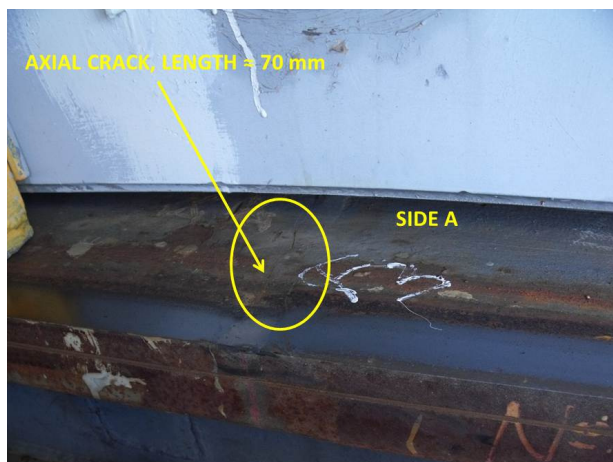
*Fig. 2.7 Axial crack. Side A.*

| Identification | Pathology | Type | Approx. size | Location |
|---|---|---|---|---|
| Fig. 2.7 | Crack | Axial | 70 mm | Side A |

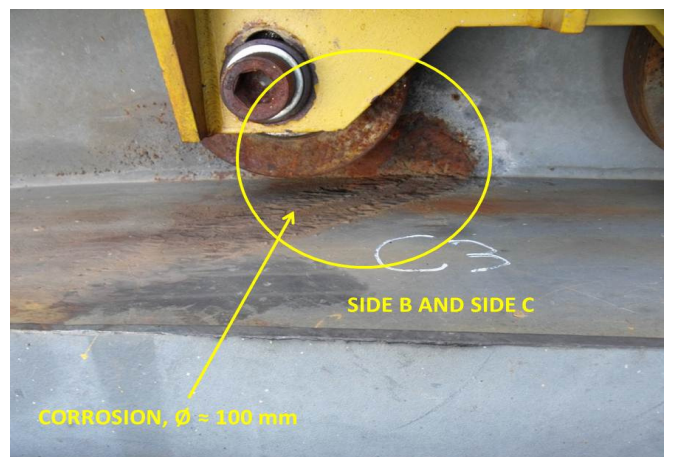
*Fig. 2.8 Corrosion. Side B and side C.*

| Identification | Pathology | Type | Approx. size | Location |
|---|---|---|---|---|
| Fig. 2.8 | Corrosion | Rust | Ø100 mm | Side B and Side C |

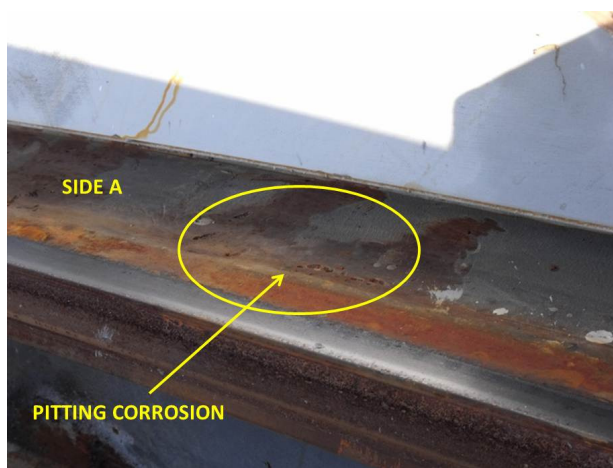
*Fig. 2.9 Pitting. Side A.*

| Identification | Pathology | Type | Approx. size | Location |
|---|---|---|---|---|
| Fig. 2.9 | Pitting | Small holes | --- | Side A |

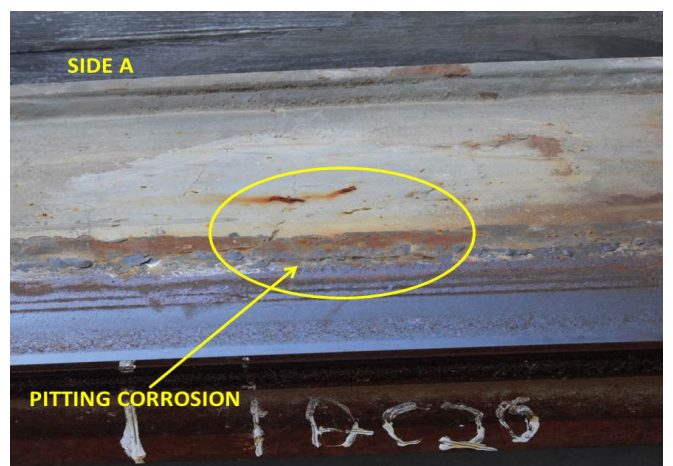
*Fig. 2.10 Pitting. Side A.*

| Identification | Pathology | Type | Approx. size | Location |
|---|---|---|---|---|
| Fig. 2.10 | Pitting | Small holes | --- | Side A |

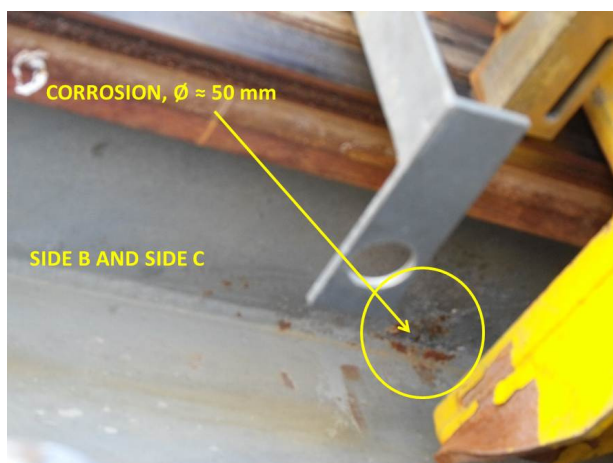
*Fig. 2.11 Corrosion. Side B and side C.*

| Identification | Pathology | Type | Approx. size | Location |
|---|---|---|---|---|
| Fig. 2.11 | Corrosion | Rust | Ø50 mm | Side B and Side C |

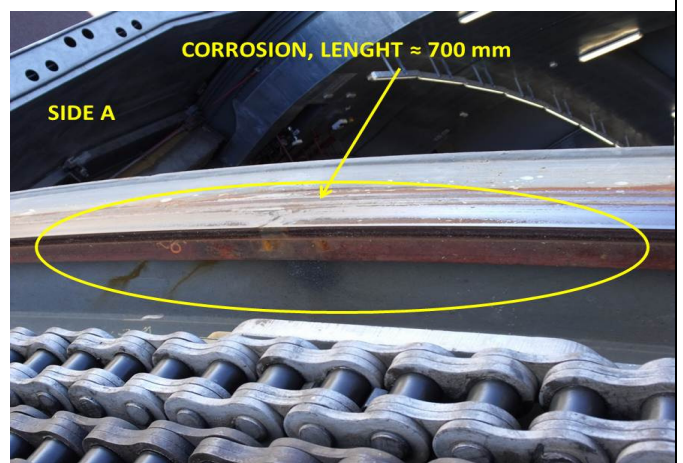
*Fig. 2.12 Corrosion. Side A.*

| Identification | Pathology | Type | Approx. size | Location |
|---|---|---|---|---|
| Fig. 2.12 | Corrosion | Rust | 700 mm | Side A |

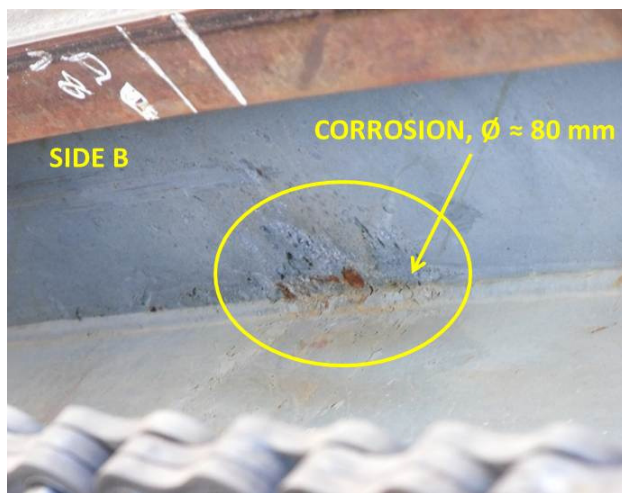
**Fig. 2.13** Corrosion. Side B.

| Identification | Pathology | Type | Approx. size | Location |
|---|---|---|---|---|
| Fig. 2.13 | Corrosion | Rust | Ø80mm | Side B |

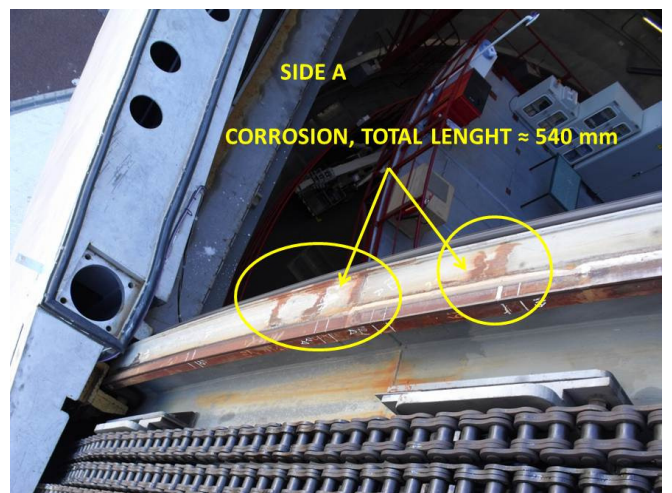
**Fig. 2.14** Corrosion. Side A.

| Identification | Pathology | Type | Approx. size | Location |
|---|---|---|---|---|
| Fig. 2.14 | Corrosion | Rust | 540 mm | Side A |

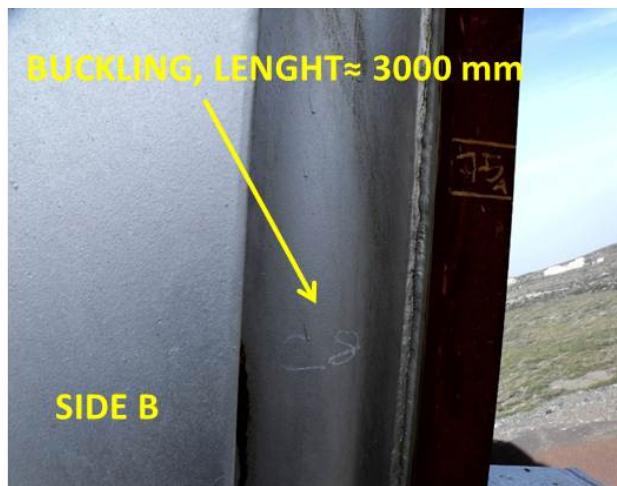
**Fig. 2.15** Buckling. Side B.

| Identification | Pathology | Type | Approx. size | Location |
|---|---|---|---|---|
| Fig. 2.15 | Buckling | Lateral deflection | 3000 mm | Side B |

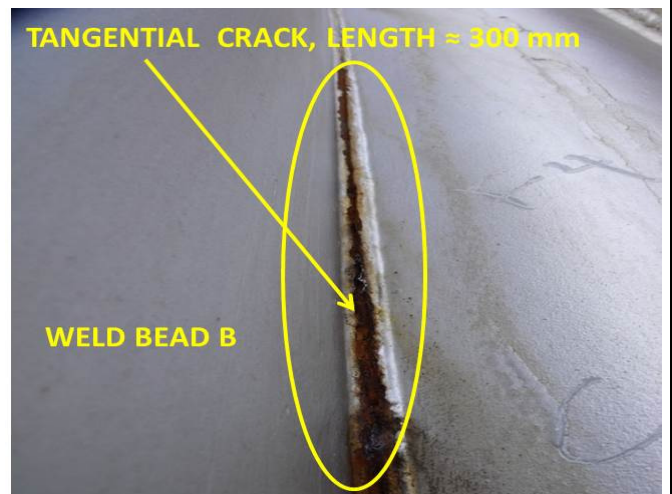
**Fig. 2.16** Tangential crack. Weld bead B.

| Identification | Pathology | Type | Approx. size | Location |
|---|---|---|---|---|
| Fig. 2.16 | Crack | Tangential | 300 mm | Weld Bead B |

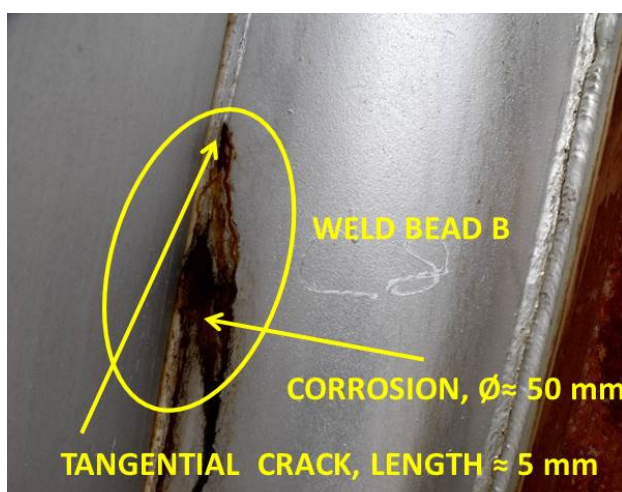
**Fig. 2.17** Tangential crack and corrosion. Weld bead B.

| Identification | Pathology | Type | Approx. size | Location |
|---|---|---|---|---|
| Fig. 2.17 | Crack and Corrosion | Tangential crack and rust | 300 mm | Weld Bead B |

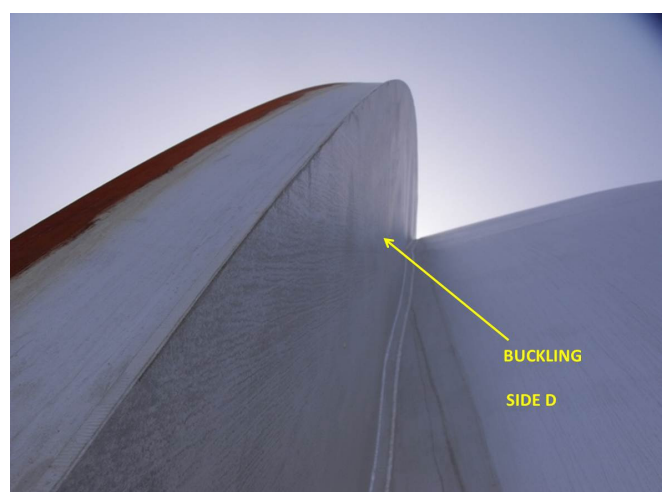
**Fig. 2.18** Buckling. Side D.

| Identification | Pathology | Type | Approx. size | Location |
|---|---|---|---|---|
| Fig. 2.18 | Buckling | Lateral deflection | --- | Side D |

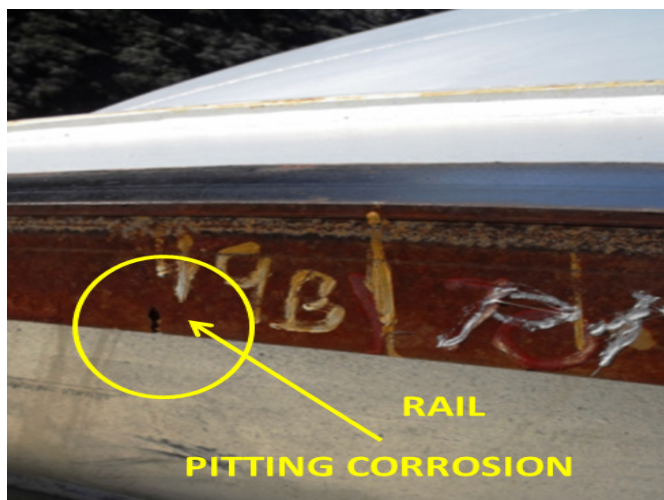
*Fig. 3.1 Pitting. Rail*

| Identification | Pathology | Type | Approx. size | Location |
|---|---|---|---|---|
| Fig. 3.1 | Pitting | Small holes | --- | Rail |

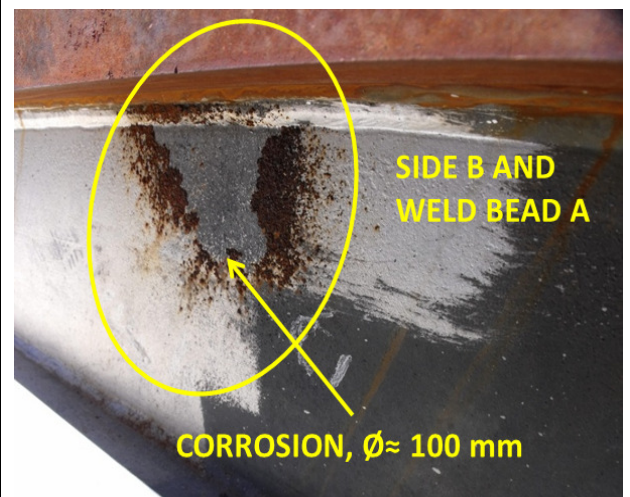
*Fig. 3.2 Corrosion. Side B and weld bead A.*

| Identification | Pathology | Type | Approx. size | Location |
|---|---|---|---|---|
| Fig. 3.2 | Corrosion | Rust | Ø100 mm | Side B and Weld bead A |

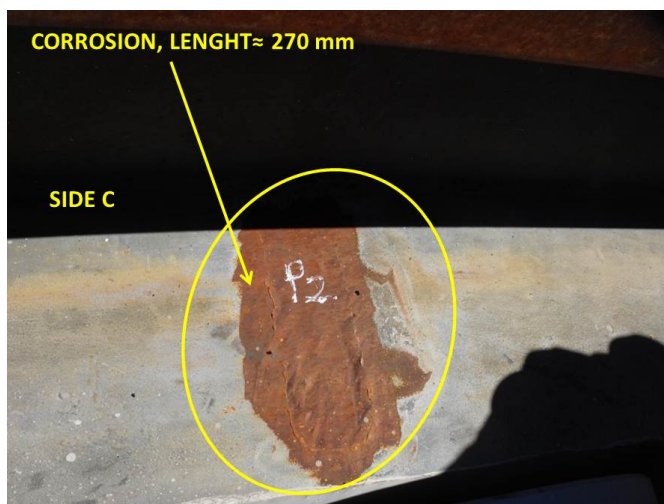
*Fig. 3.3 Corrosion and Pitting. Side C.*

| Identification | Pathology | Type | Approx. size | Location |
|---|---|---|---|---|
| Fig. 3.3 | Corrosion and Pitting | Rust and small holes | 270 mm | Side C |

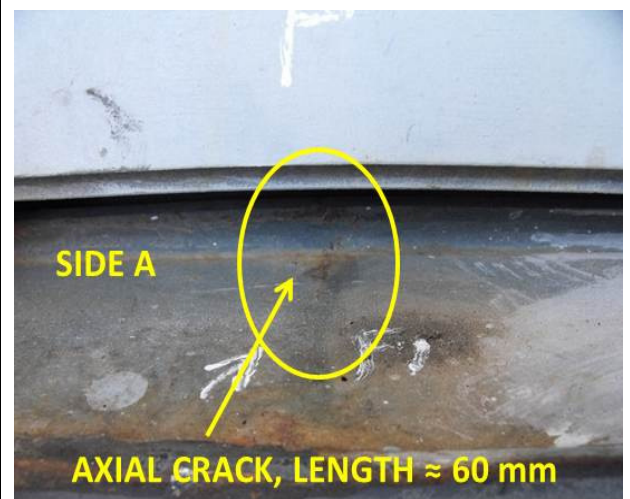
*Fig. 3.4 Axial crack. Side A.*

| Identification | Pathology | Type | Approx. size | Location |
|---|---|---|---|---|
| Fig. 3.4 | Crack | Axial | 60 mm | Side A |

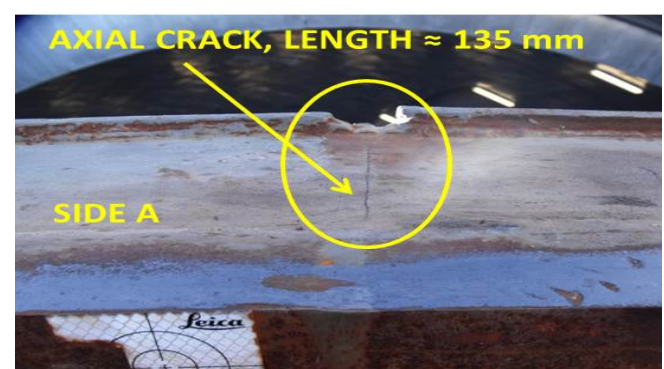
*Fig. 3.5 Axial crack. Side A.*

| Identification | Pathology | Type | Approx. size | Location |
|---|---|---|---|---|
| Fig. 3.5 | Crack | Axial | 135 mm | Side A |

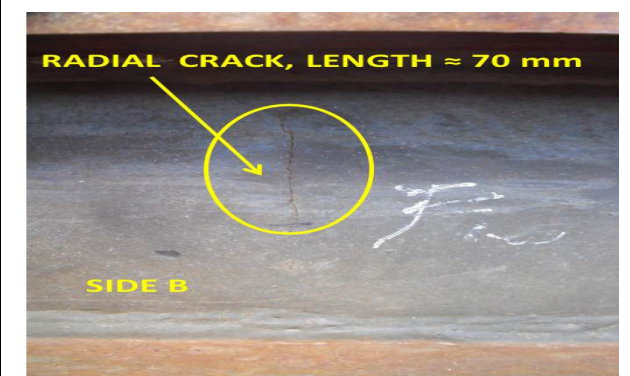
*Fig. 3.6 Radial crack. Side B.*

| Identification | Pathology | Type | Approx. size | Location |
|---|---|---|---|---|
| Fig. 3.6 | Crack | Radial | 70 mm | Side B |

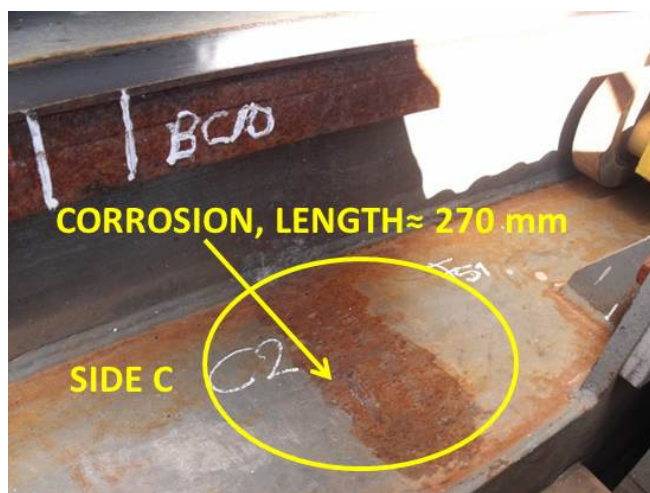
**Fig. 3.7** Corrosion. Side C.

| Identification | Pathology | Type | Approx. size | Location |
|---|---|---|---|---|
| Fig. 3.7 | Corrosion | Rust | 270 mm | Side C |

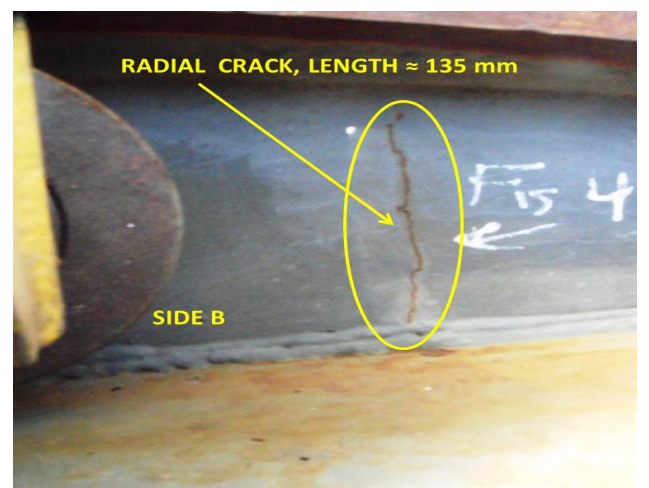
**Fig. 3.8** Radial crack. Side B.

| Identification | Pathology | Type | Approx. size | Location |
|---|---|---|---|---|
| Fig. 3.8 | Crack | Radial | 135 mm | Side B |

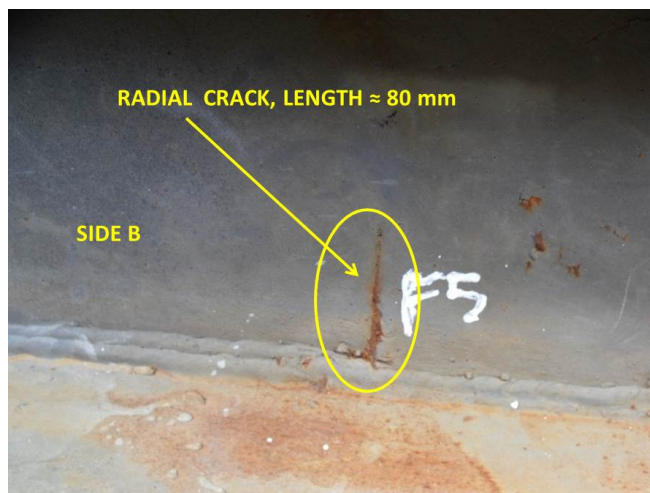
**Fig. 3.9** Radial crack. Side B.

| Identification | Pathology | Type | Approx. size | Location |
|---|---|---|---|---|
| Fig. 3.9 | Crack | Radial | 80 mm | Side B |

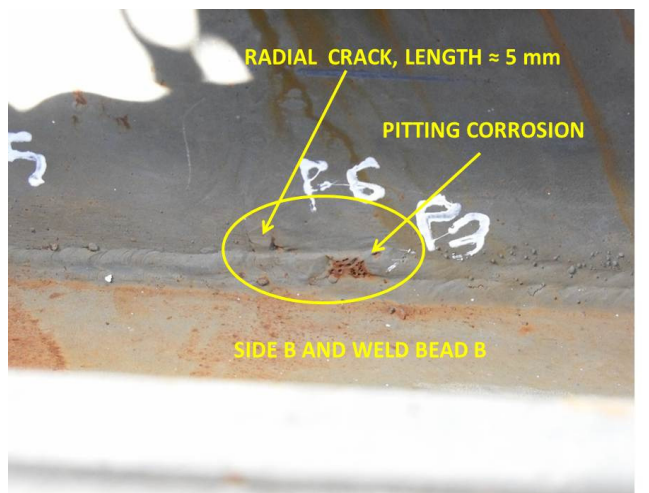
**Fig. 3.10** Radial crack and Pitting. Side B and weld bead B.

| Identification | Pathology | Type | Approx. size | Location |
|---|---|---|---|---|
| Fig. 3.10 | Crack and Pitting | Radial crack and small holes | 5 mm | Side B and Weld Bead B |

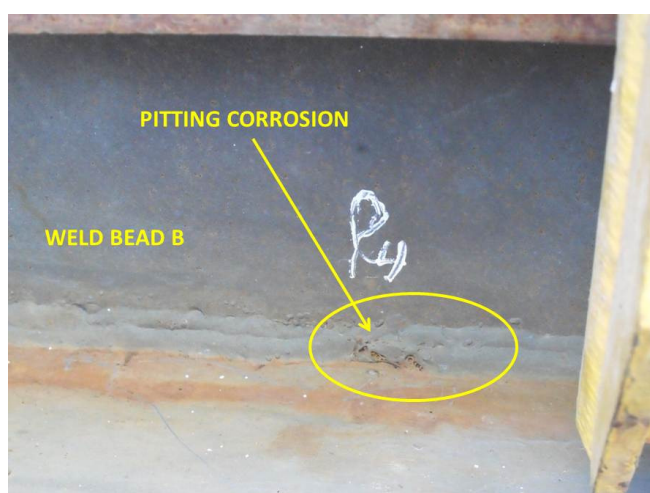
**Fig. 3.11** Pitting. Weld bead B.

| Identification | Pathology | Type | Approx. size | Location |
|---|---|---|---|---|
| Fig. 3.11 | Pitting | Small holes | --- | Weld bead B |

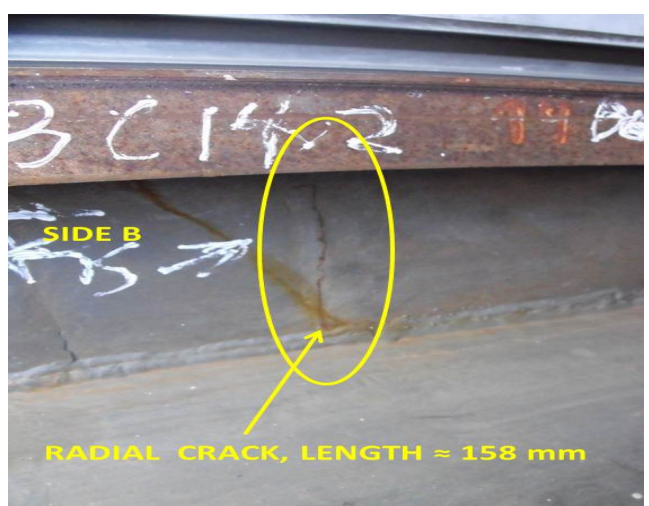
**Fig. 3.12** Radial crack. Side B.

| Identification | Pathology | Type | Approx. size | Location |
|---|---|---|---|---|
| Fig. 3.12 | Crack | Radial | 158 mm | Side B |

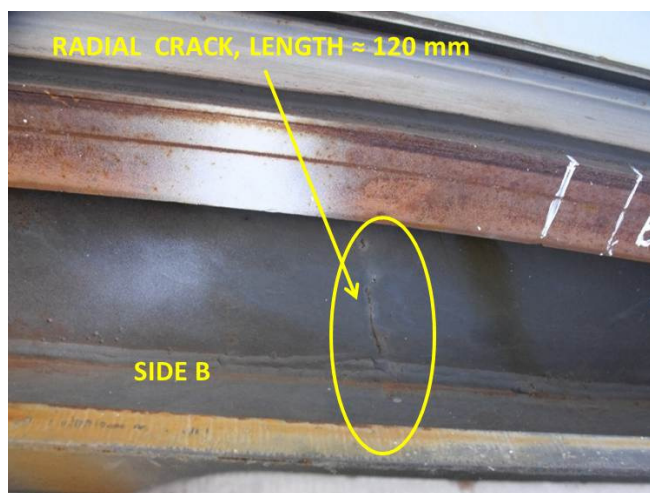
*Fig. 3.13 Radial crack. Side B.*

| Identification | Pathology | Type | Approx. size | Location |
|---|---|---|---|---|
| Fig. 3.13 | Crack | Radial | 120 mm | Side B |

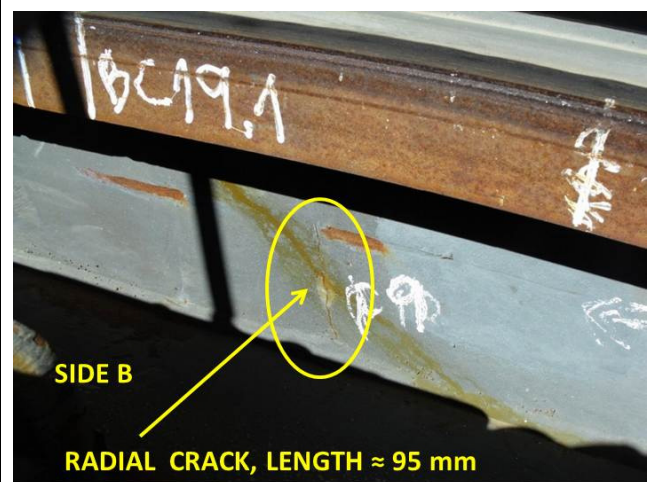
*Fig. 3.14 Radial crack. Side B.*

| Identification | Pathology | Type | Approx. size | Location |
|---|---|---|---|---|
| Fig. 3.14 | Crack | Radial | 95 mm | Side B |

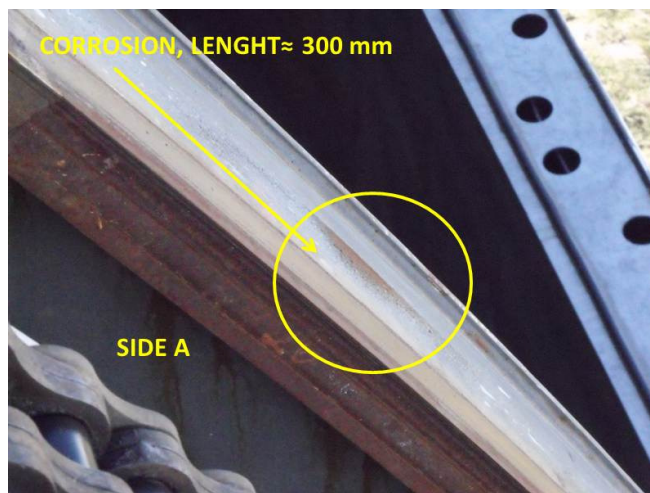
*Fig. 3.15 Corrosion. Side A.*

| Identification | Pathology | Type | Approx. size | Location |
|---|---|---|---|---|
| Fig. 3.15 | Corrosion | Rust | 300 mm | Side A |

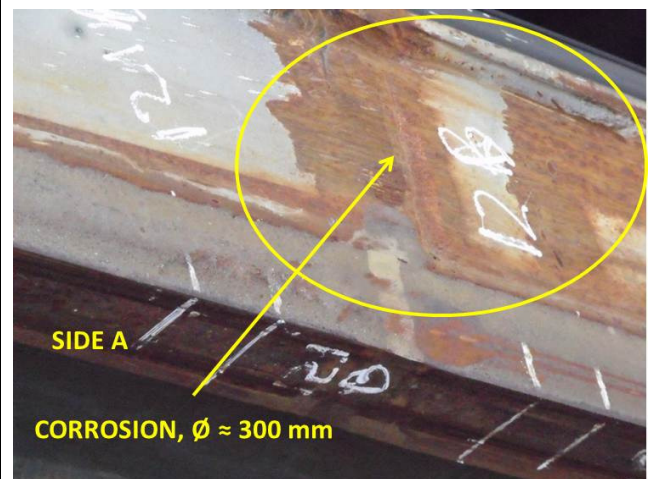
*Fig. 3.16 Corrosion. Side A.*

| Identification | Pathology | Type | Approx. size | Location |
|---|---|---|---|---|
| Fig. 3.16 | Corrosion | Rust | Ø 300 mm | Side A |

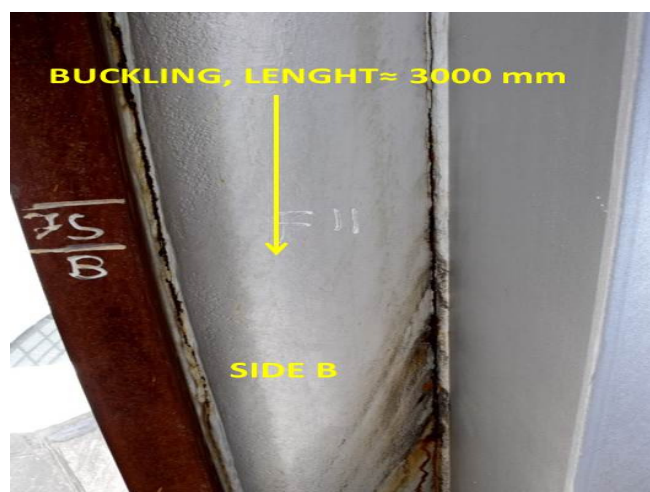
*Fig. 3.17 Buckling. Side B.*

| Identification | Pathology | Type | Approx. size | Location |
|---|---|---|---|---|
| Fig. 3.17 | Buckling | Lateral deflection | 3000 mm | Side B |

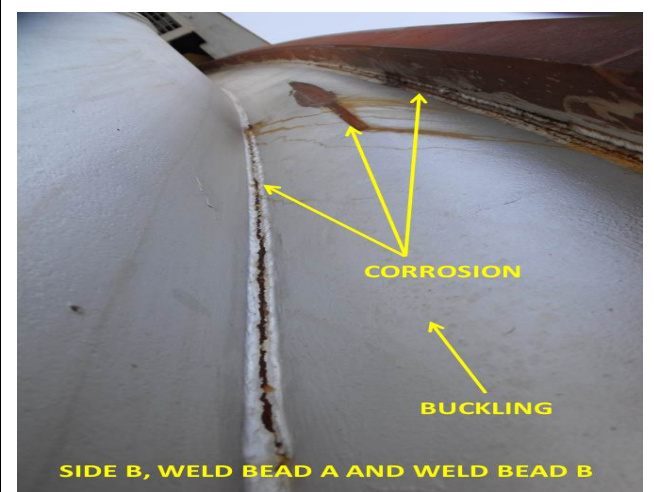
*Fig. 3.18 Buckling and corrosion. Side B, weld bead A and weld bead B.*

| Identification | Pathology | Type | Approx. size | Location |
|---|---|---|---|---|
| Fig. 3.18 | Corrosion and Buckling | Rust and lateral deflection | --- | Side B, Weld Bead A and Weld Bead B |

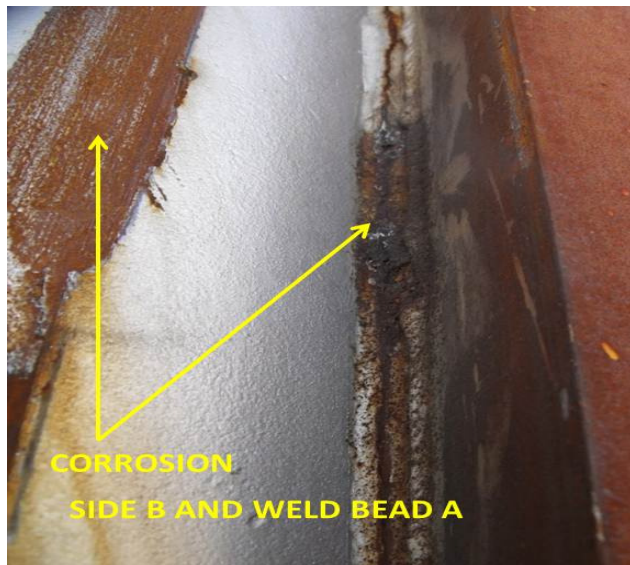
*Fig. 3.19 Corrosion. Side A and weld bead B.*

| Identification | Pathology | Type | Approx. size | Location |
|---|---|---|---|---|
| Fig. 3.19 | Corrosion | Rust | --- | Side B, Weld Bead A |

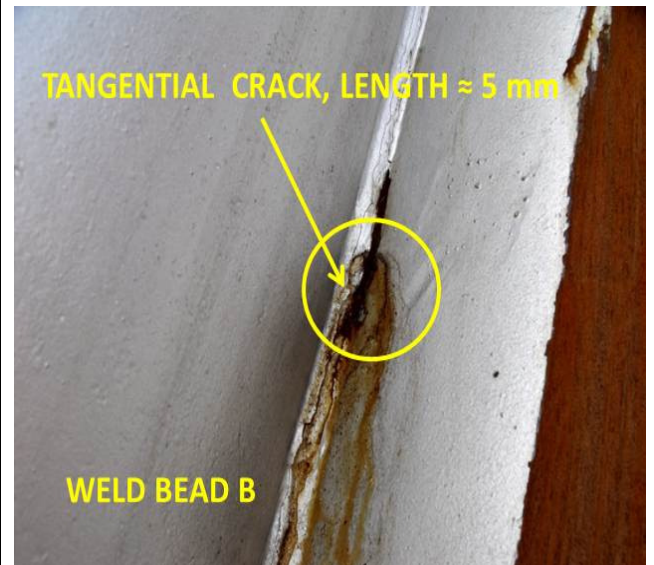
*Fig. 3.20 Tangential crack. Weld bead B.*

| Identification | Pathology | Type | Approx. size | Location |
|---|---|---|---|---|
| Fig. 3.20 | Crack | Tangencial | 5 mm | Weld Bead B |

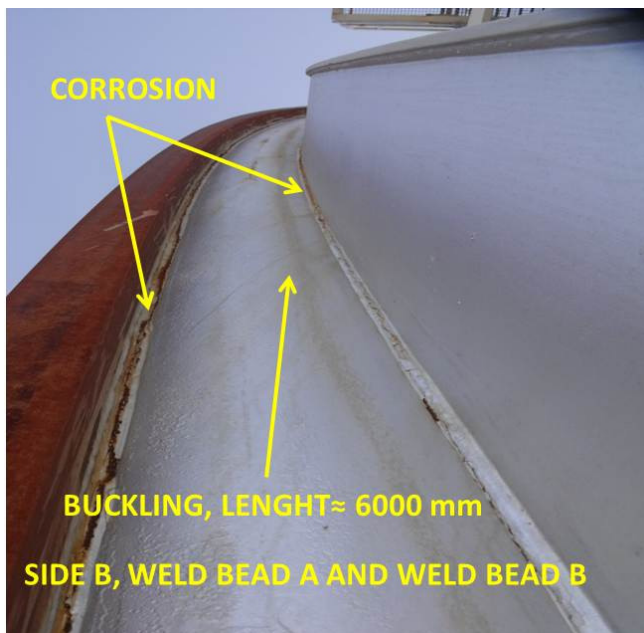
*Fig. 3.21 Corrosion and Buckling. Side B, weld bead A and weld bead B.*

| Identification | Pathology | Type | Approx. size | Location |
|---|---|---|---|---|
| Fig. 3.21 | Corrosion and Buckling | Rust and lateral deflection | 6000 mm | Side B, Weld Bead A and Weld Bead B |

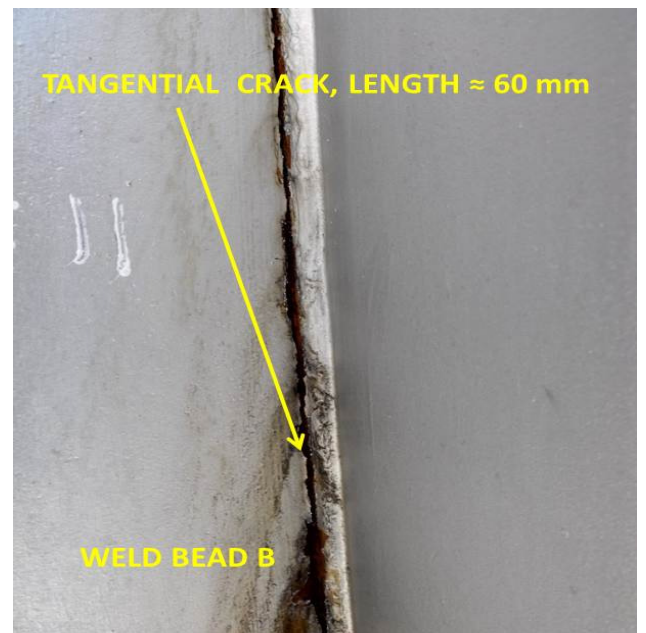
*Fig. 3.22 Tangential crack. Weld bead B.*

| Identification | Pathology | Type | Approx. size | Location |
|---|---|---|---|---|
| Fig. 3.22 | Crack | Tangencial | 60 mm | Weld Bead B |

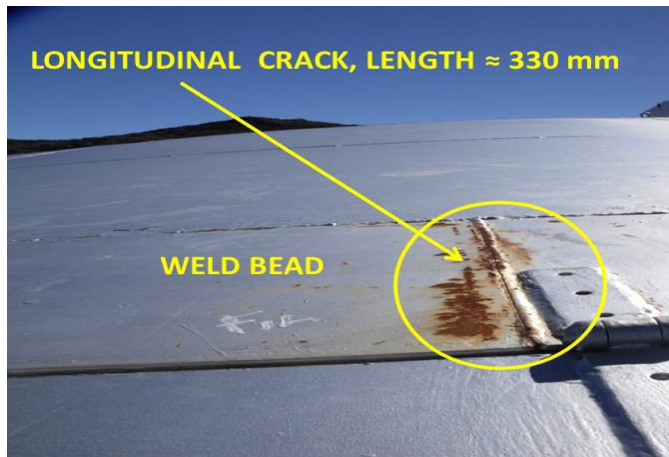
*Fig. 4.1* Longitudinal crack. Weld bead.

| Identification | Pathology | Type | Approx. size | Location |
|---|---|---|---|---|
| Fig. 4.1 | Crack | Longitudinal | 330 mm | Weld bead |

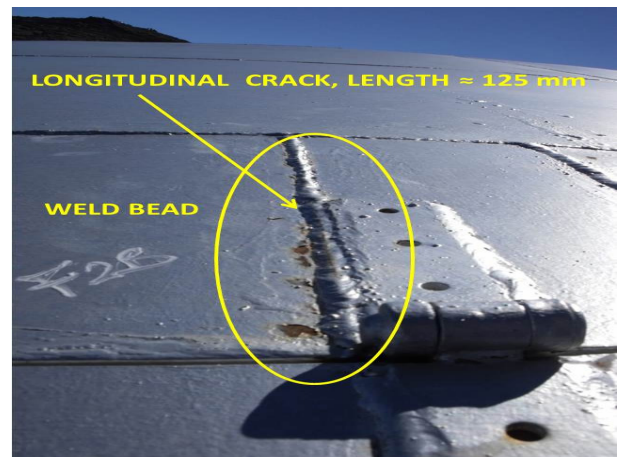
*Fig. 4.2* Longitudinal crack. Weld bead.

| Identification | Pathology | Type | Approx. size | Location |
|---|---|---|---|---|
| Fig. 4.2 | Crack | Longitudinal | 125 mm | Weld bead |

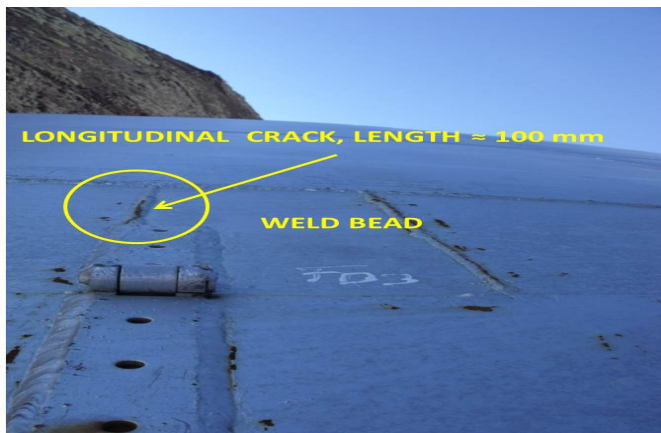
*Fig. 4.3* Longitudinal crack. Weld bead.

| Identification | Pathology | Type | Approx. size | Location |
|---|---|---|---|---|
| Fig. 4.3 | Crack | Longitudinal | 100 mm | Weld bead |

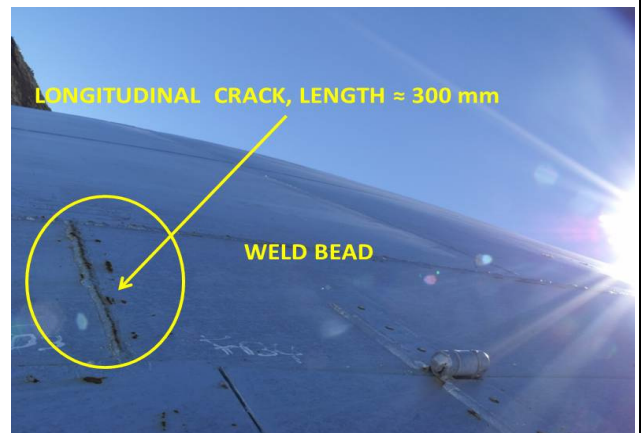
*Fig. 4.4* Longitudinal crack. Weld bead.

| Identification | Pathology | Type | Approx. size | Location |
|---|---|---|---|---|
| Fig. 4.4 | Crack | Longitudinal | 300 mm | Weld bead |

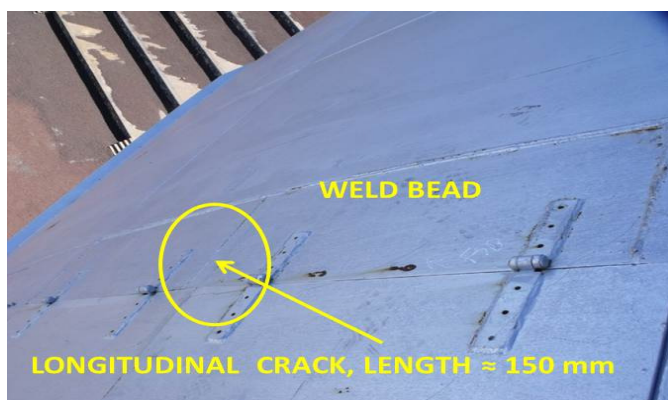
*Fig. 4.5* Longitudinal crack. Weld bead.

| Identification | Pathology | Type | Approx. size | Location |
|---|---|---|---|---|
| Fig. 4.5 | Crack | Longitudinal | 150 mm | Weld bead |

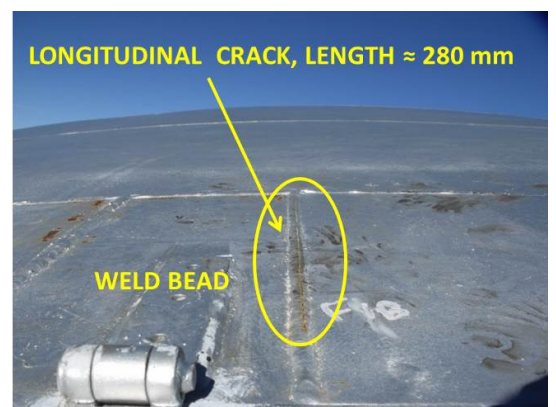
*Fig. 4.6* Longitudinal crack. Weld bead.

| Identification | Pathology | Type | Approx. size | Location |
|---|---|---|---|---|
| Fig. 4.6 | Crack | Longitudinal | 280 mm | Weld bead |

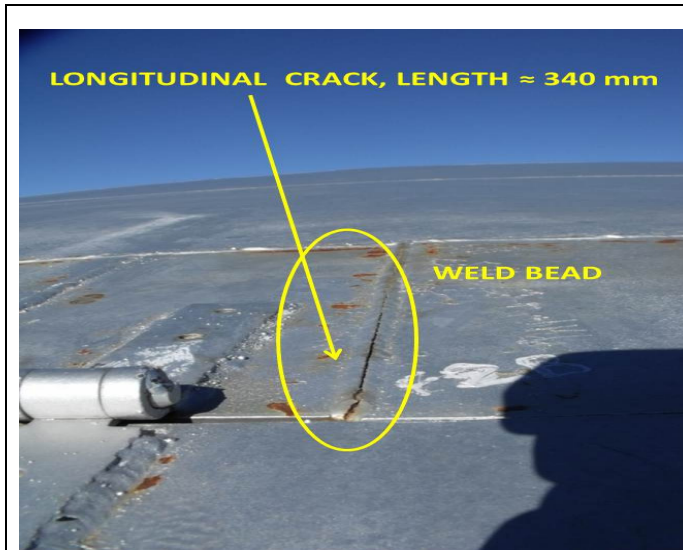
**Fig. 4.7** Longitudinal crack. Weld bead.

| Identification | Pathology | Type | Approx. size | Location |
|---|---|---|---|---|
| Fig. 4.7 | Crack | Longitudinal | 340 mm | Weld bead |

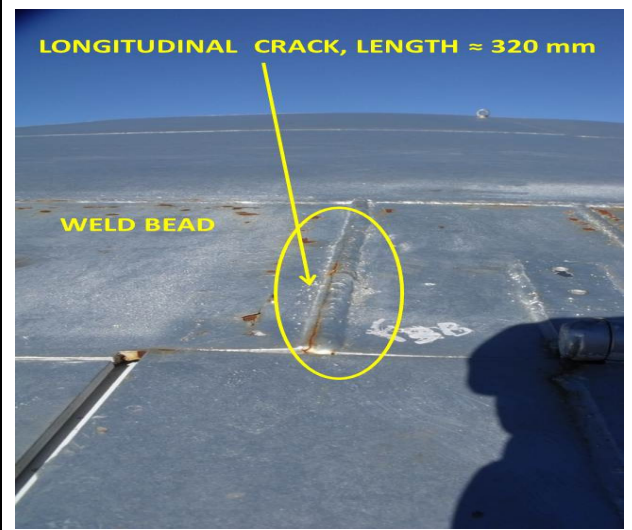
**Fig. 4.8** Longitudinal crack. Weld bead.

| Identification | Pathology | Type | Approx. size | Location |
|---|---|---|---|---|
| Fig. 4.8 | Crack | Longitudinal | 320 mm | Weld bead |

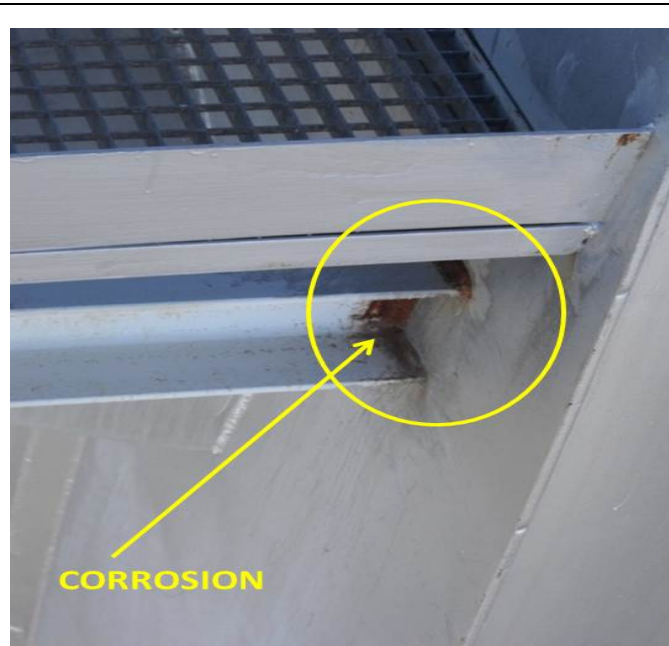
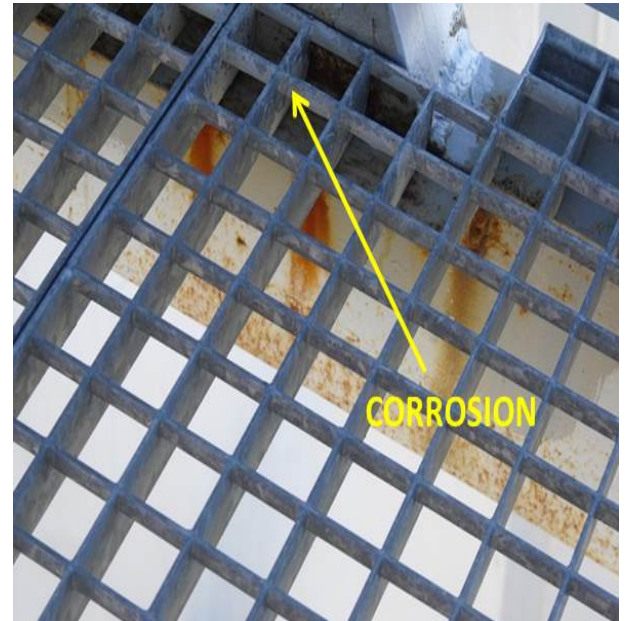
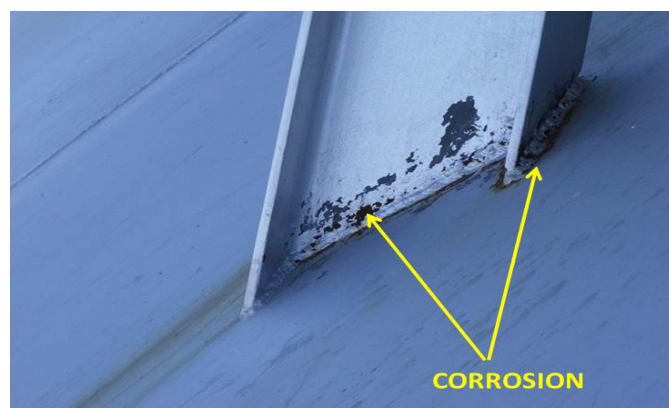
The corrosion is present as rust and is a result of poor primer paint and paint absence in several areas of the dome. Other cause is the accumulation of water in several points as consequence of an inadequate evacuation of rainwater.

*Fig. 5.1 Corrosion on the support beams of external access platforms*

*Fig. 5.2 Corrosion on the support beams of external access platforms*

*Fig. 5.3 Corrosion on the support beams of external access platforms*
