**DOME**

**Damages on the dome arch beams and  
shutters**

**Code :** RPT/EDIF/0385-R  
**Issue :** 1.A  
**Date :** 05/03/13  
**No. of pages :** 23

Gran Telescopio de Canarias, S.A.

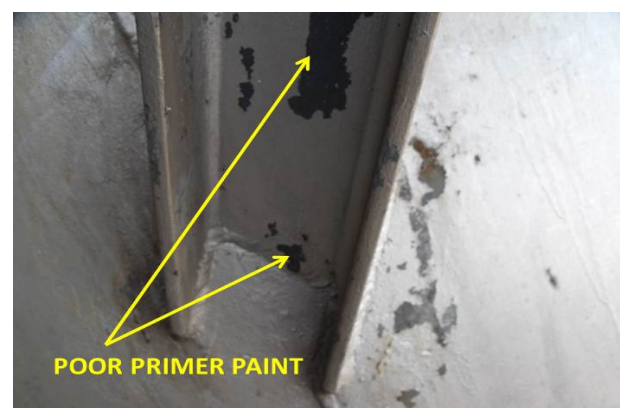
The corrosion is present as rust and is a result of poor primer paint and paint absence in several areas of the dome. Other cause is the accumulation of water in several points as consequence of an inadequate evacuation of rainwater.

*Fig. 5.4 Poor primer paint on the support beams of external access platforms*

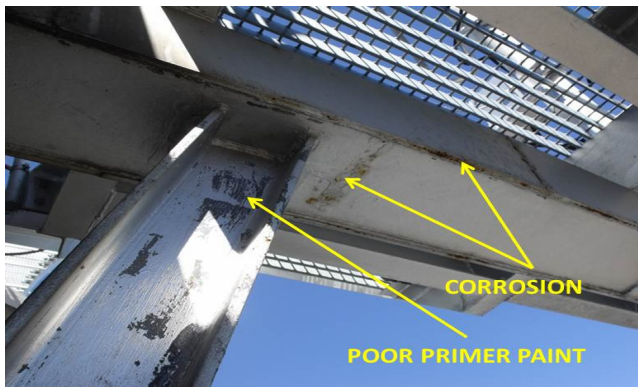
**Fig. 5.5** Poor primer paint and corrosion on the support beams of external access platforms

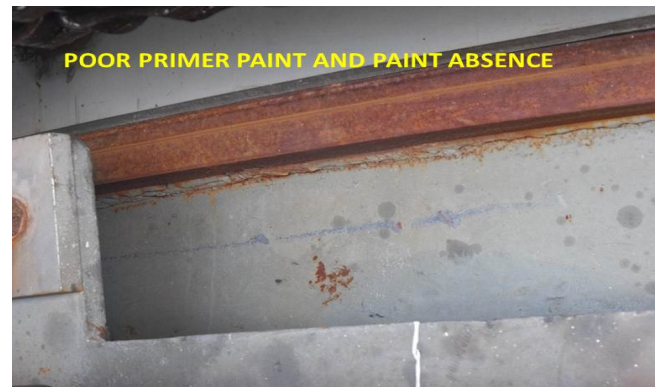
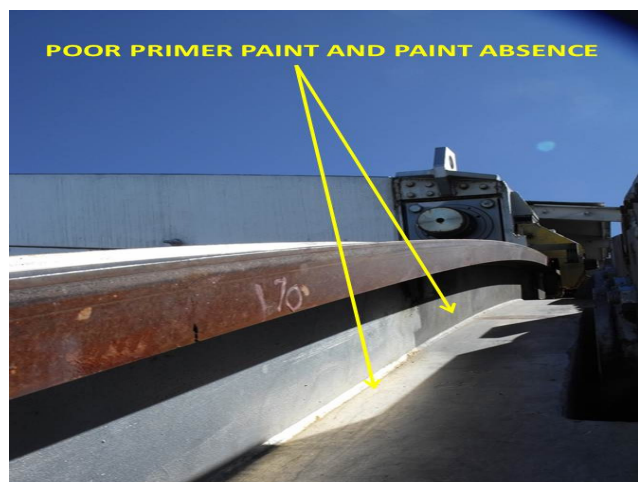
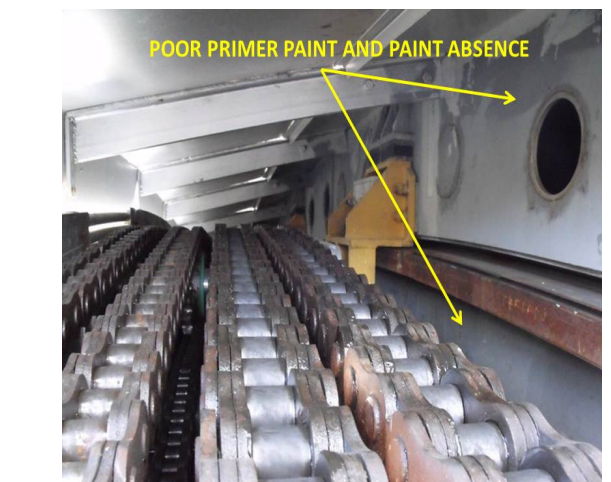
**Fig. 5.6** Poor primer paint and paint absence

**Fig. 5.7** Poor primer paint and paint absence

**Fig. 5.8** Poor primer paint and paint absence

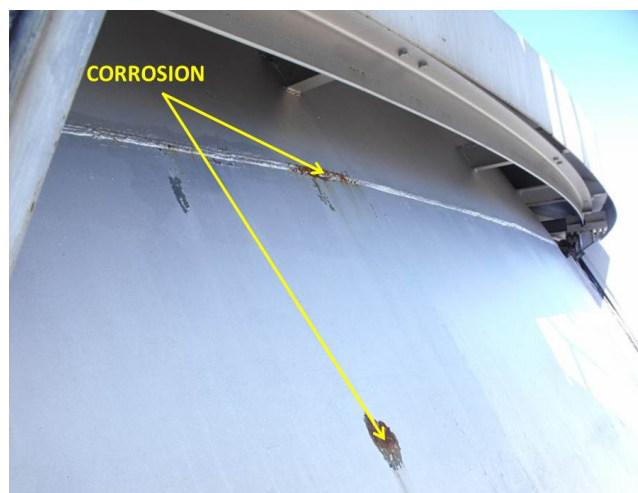
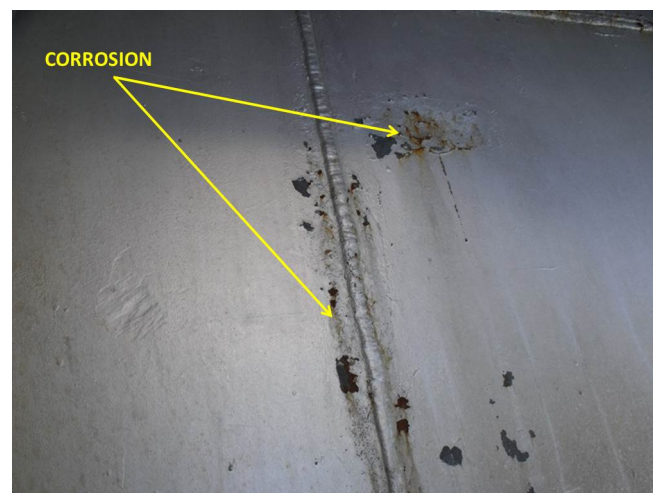
**Fig. 5.9** Corrosion on the steel plates that covering the dome

**Fig. 5.10** Corrosion on the steel plates that covering the dome
