**DOME**

**Damages on the dome arch beams and  
shutters**

**Code :** RPT/EDIF/0385-R  
**Issue :** 1.A  
**Date :** 05/03/13  
**No. of pages :** 23

Gran Telescopio de Canarias, S.A.

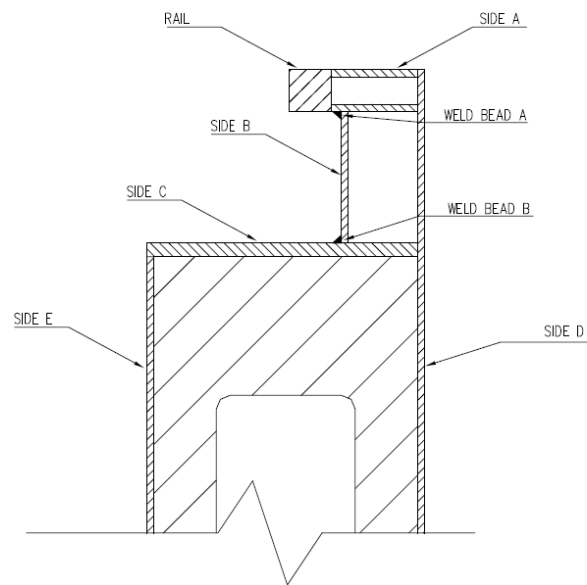
**Fig. 1.4** Schematic view of the arch beam section. Identification of areas.

The following sections present a photographic report of the observed damages indicating the location and a short description of the defects. Photographic report of beams damages refers to defects positions presented in fig. 1.2 and fig. 1.3 and location of defects on the beam section according to areas defined in fig. 1.4. Photographic report of shutters damages refers to defects positions according to fig. 1.5.
